**“THEN YOU’LL HAVE A FINE HOUSE...”:
THE NEW FRAME HOUSE OF NORWEGIAN IMMIGRANTS
ANNA AND HANS GOULSON,
SWIFT COUNTY, MINNESOTA**

April 2011

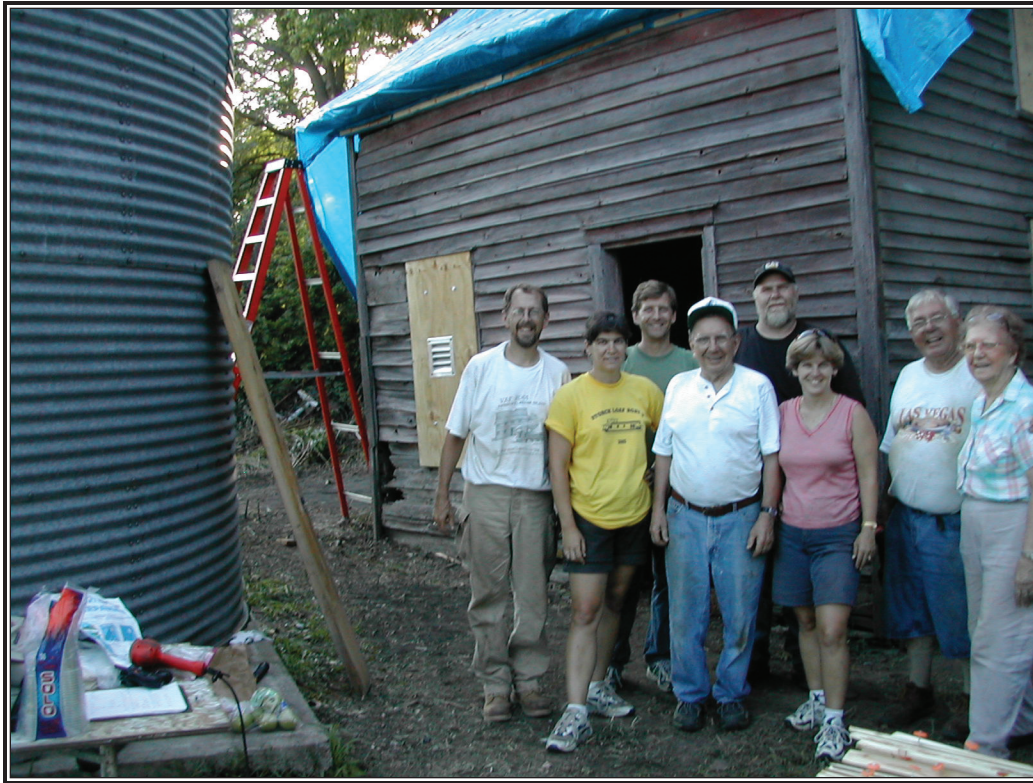
Figure 1.1. Dr. Linebaugh and Goulson family members in front of the Goulson frame house after documentation and stabilization.

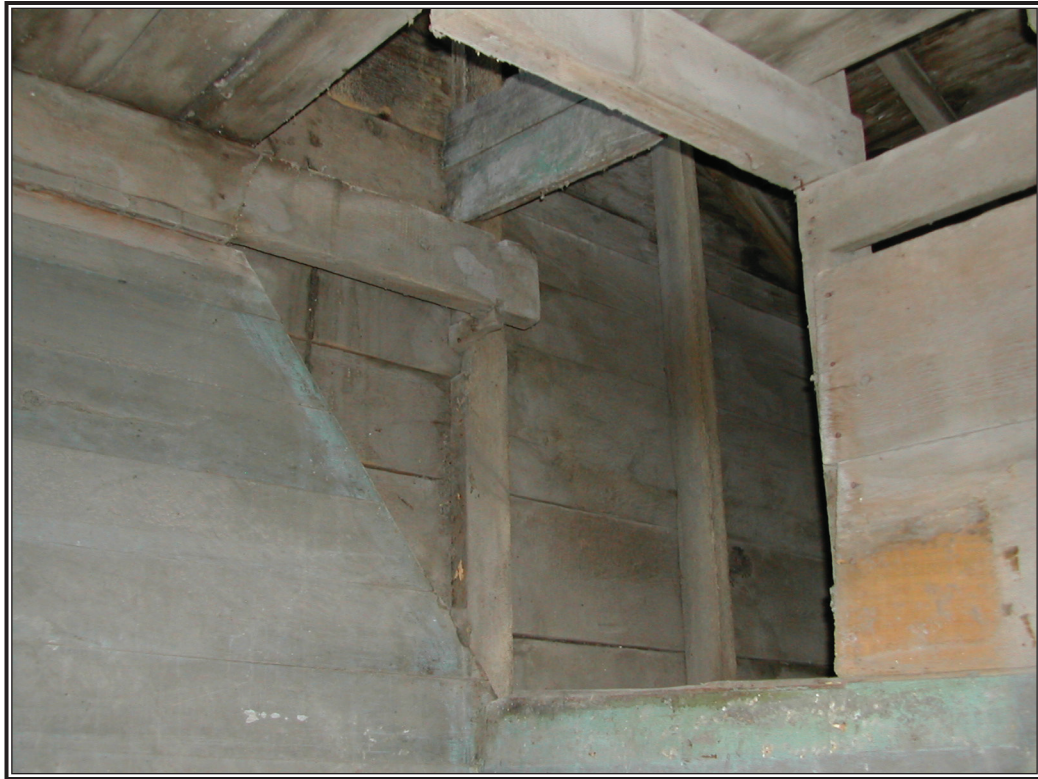
Beneath the dirt and debris were sections of original tongue and groove flooring, as well as some of the floor joists; small sections of flooring were identified in the rear room. A joist, added to close off the staircase opening, was removed, as were boards used to fill the stair opening on the north wall of the main room (Figure 3.3). These elements were measured and photographed before removal. The stair had been removed and stair opening covered during Period II when the building was converted into a granary.

Figure 3.3. When the building was converted to a granary, the original staircase was removed and the stairwell boarded over. The joist and boards used to fill the stair opening on the north wall of the main room were removed during the documentation.

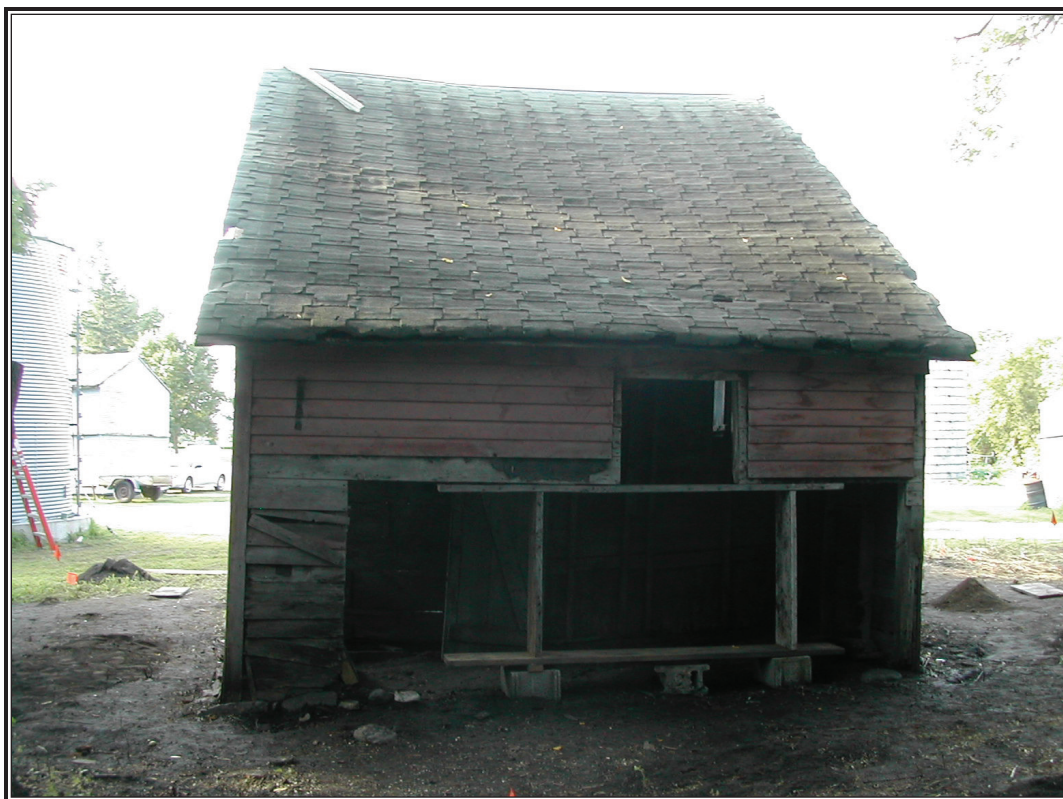
The north façade has been the most significantly altered since the structure was repurposed. All but the westernmost 2' of the bottom half of the wall, both framing and siding, has been removed to provide access for farm equipment storage inside the house's back room (Figure 3.13). The 7' tall wall previously had a single opening slightly to the east of center. It was likely a door, since it is the same width as the house's other door frames -- however, only the top two feet of the frame remains, so it is difficult to establish with certainty.

Figure 3.13. North (rear) facade of the Goulson frame house.

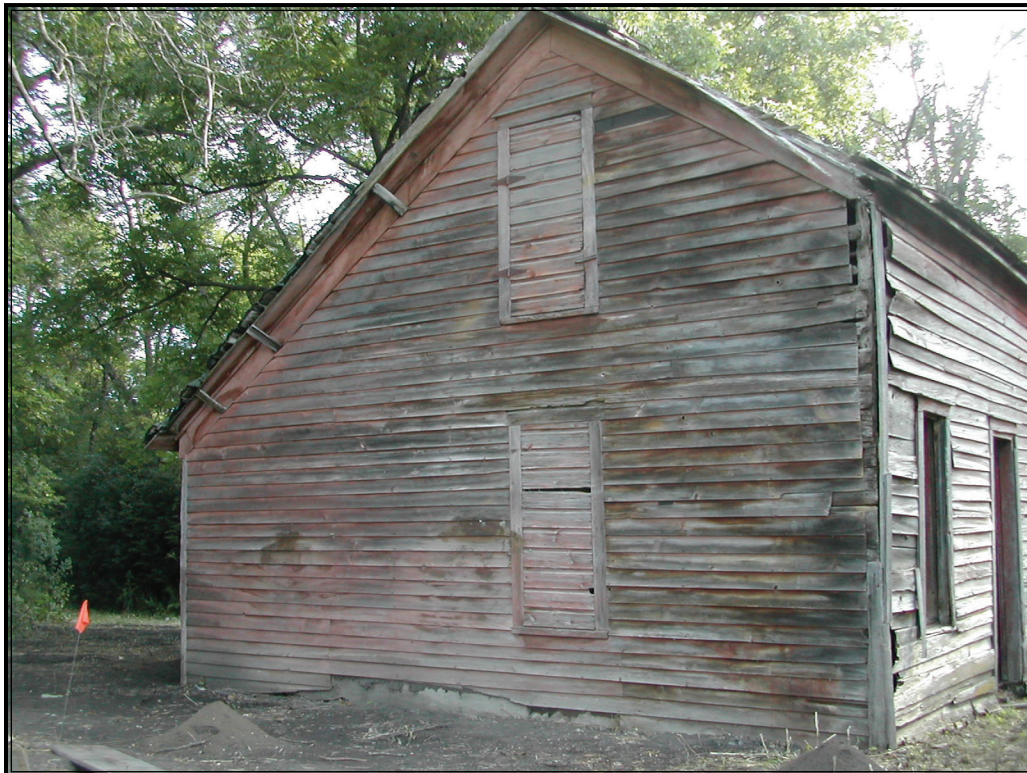
The west façade of the house appears to have suffered the most from natural causes. Its two window bays were boarded up with a makeshift shutters fashioned out of 1-inch planks and covered on the exterior with weatherboarding similar to the rest of the facade (Figure 5.7). As with the other facades, there are pieces of missing weatherboard and trim, particularly in the southwest corner. As noted above, this area has experienced major decay, along with the roof above, primarily due to moisture problems. The front (south) wall has begun to completely pull away from the west wall at the corner as a result of rotted and warped wood (Figure 5.8).

Figure 5.7. Shutters made of weatherboards cover the window openings on the west facade.

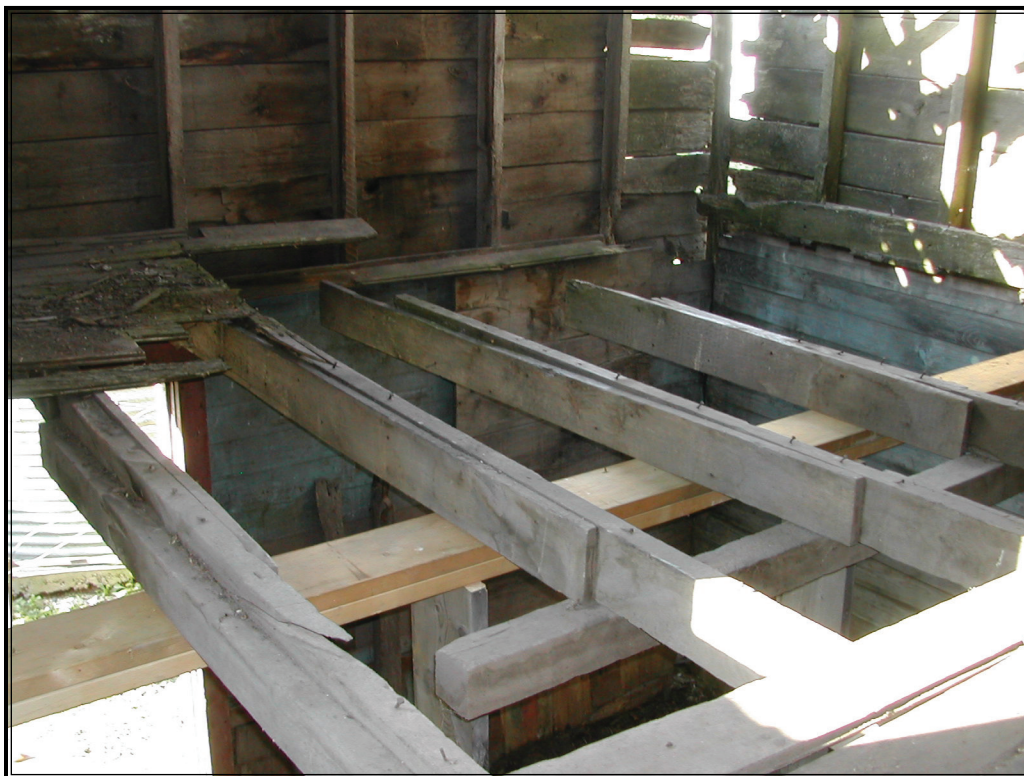
having been used as a storage room for grain and later filled with debris. A number of the wooden structural elements, especially floor joists and flooring, are severely deteriorated or completely missing. After all of the machinery was removed and the dirt and debris was shoveled out, large sections of the original tongue and groove floor were uncovered. In general, the subfloor and the floor are structurally unsound and the wood deteriorated beyond repair. Previous damage to the floor had been patched with pieces of corrugated metal and old license plates. The ceiling in the main room had been removed, probably when the structure was converted to a granary, leaving only the exposed second floor joists (Figure 5.9). Several of the joists in the southwestern section had deteriorated and detached from the front wall, hanging unsafely overhead; again, this damage resulted from the failure of the roof system.

Figure 5.9. Exposed joists are all that are left of the first floor ceiling after the frame house was converted to a granary.

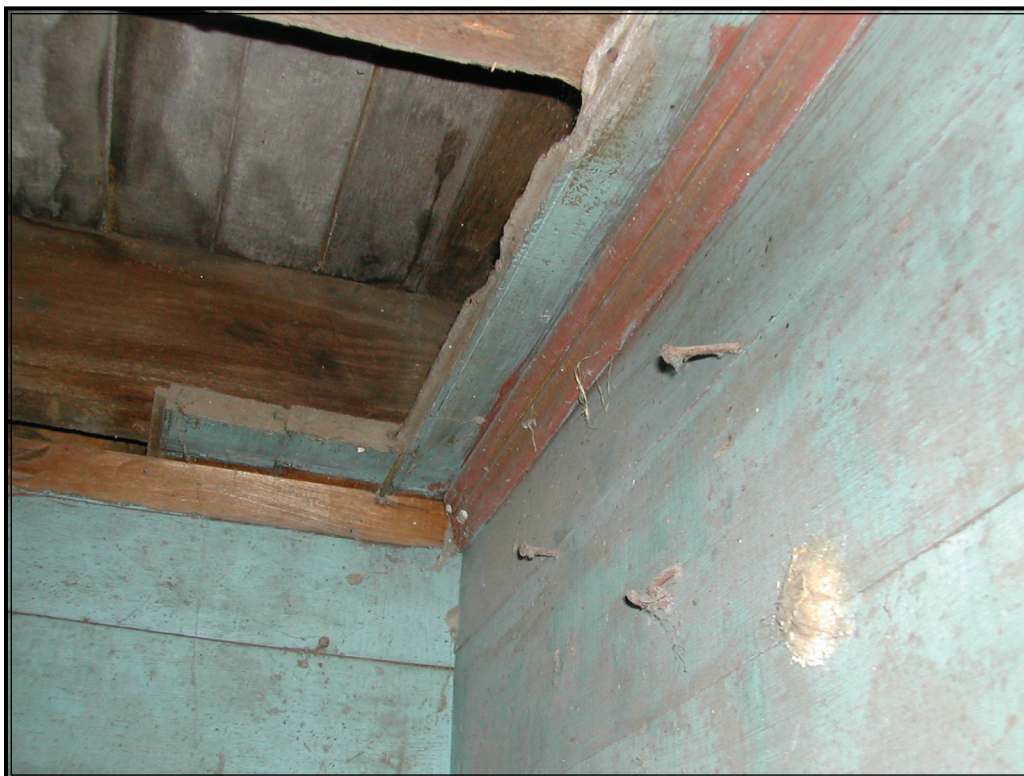
The crown molding sits just below the height of the now-missing tongue and groove ceiling (Figure 5.10). All of the horizontal wood panels above the chair rail level are in place and much of the original blue paint is still visible. While the 2" chair rail on this wall is missing, all of the vertical, painted bead board wainscoting is intact; while intact, the wainscoting in the southwest corner exhibits water damage and rot. All of the trim remains around both the door and window frames, except for a small 1" piece at the top of the door.

Figure 5.10. The red crown molding sits just below the former tongue-in-groove ceiling.

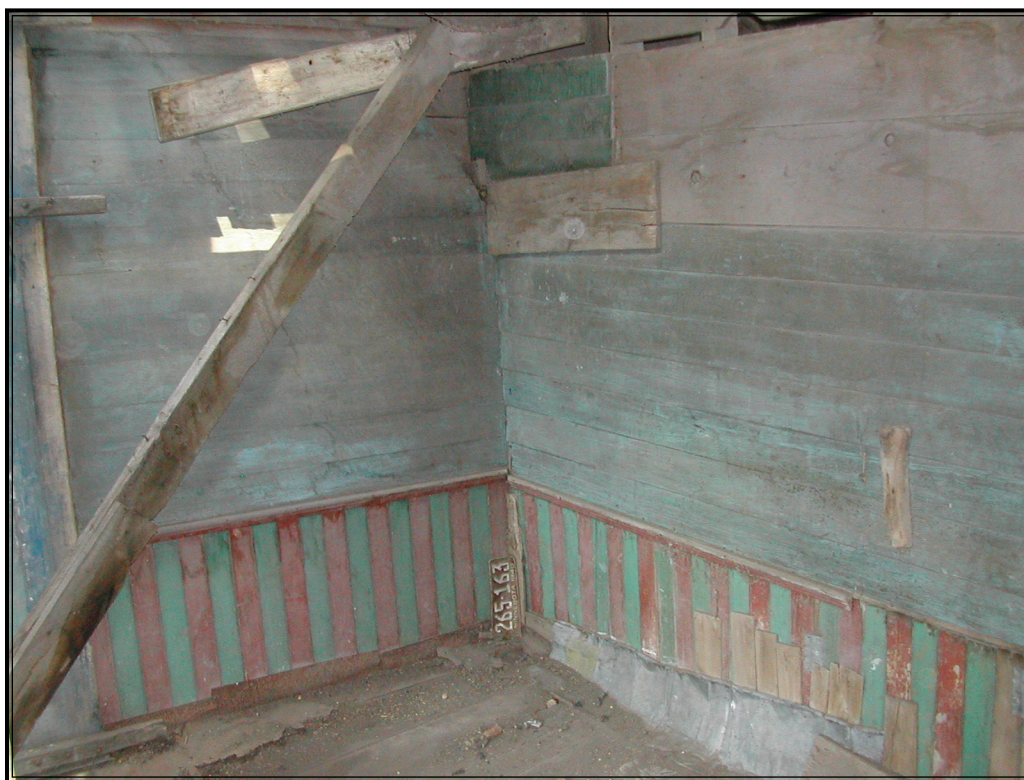
closed up with an additional 1"x10" board and several pieces of tongue & groove flooring (painted bright green) (Figure 5.11). None of the trim around the doorway remains. However, the framing studs are in place, and these bear evidence of the original trim pieces. On the remaining spaces of wall above the chair rail, horizontal paneling is intact and has the same blue paint finish as the rest of the main room. Half of the original chair rail is still in place, and more than half (37) of the vertical wainscoting panels remain on the lower part of the wall, all still displaying the red or green paint of the original scheme. The remaining panels are missing.

Figure 5.11. The original stair was removed and the stair opening closed up when the frame house was adapted for use as a granary.

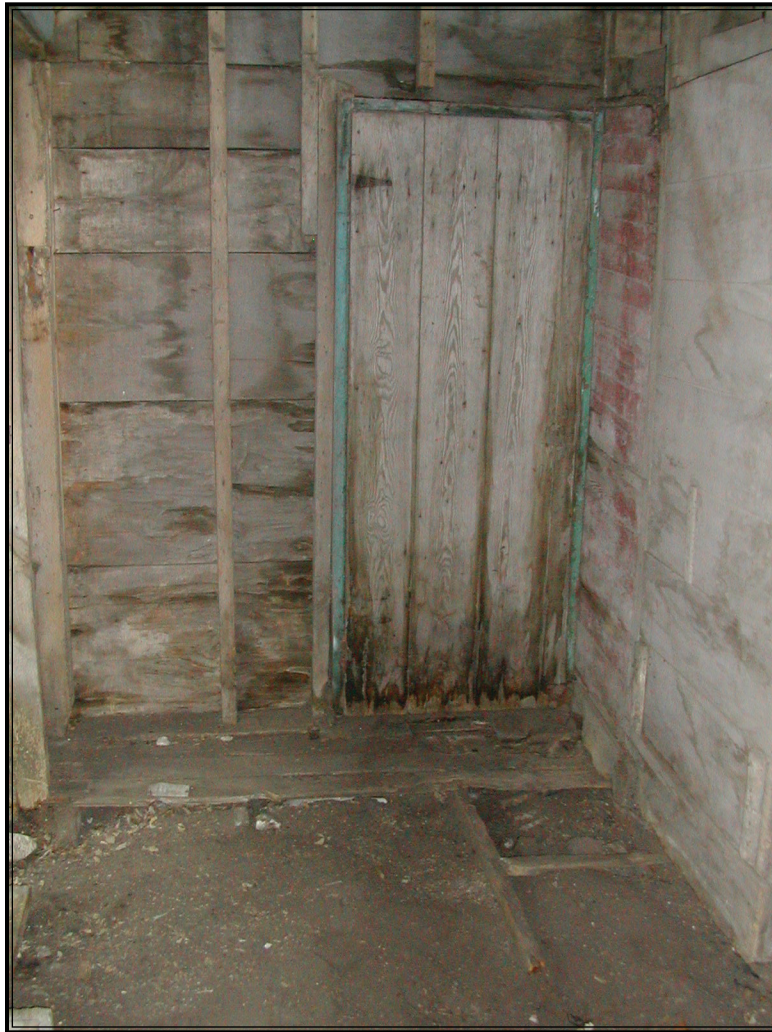
The rear room, where one of the exterior walls has been partially removed, has no interior finishes still in place. The wood wall framing members are exposed, and only small sections of floor joists are left intact (Figure 5.12). The modifications to the north exterior wall were significant, but the wall was not properly rebuilt to accommodate such an alteration. Lacking proper structural support, the center of the rear wall has sagged noticeably.

Figure 5.12. In the rear room of the Goulson frame house, the framing members are exposed and only small sections of floorboards survive.

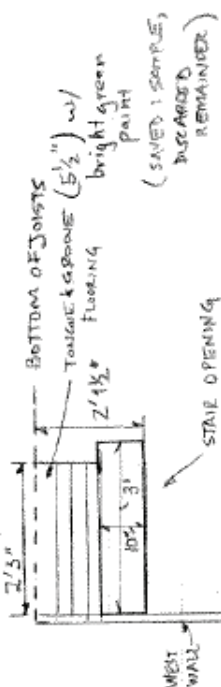
MEASURED & SKETCHED WALL BOARDS (P. PHOTO) USED TO FILL STAIR OPENING ON N. WALL MAIN ROOM

ADDED BOARDS ATTACHED W/ WIRE NAILS

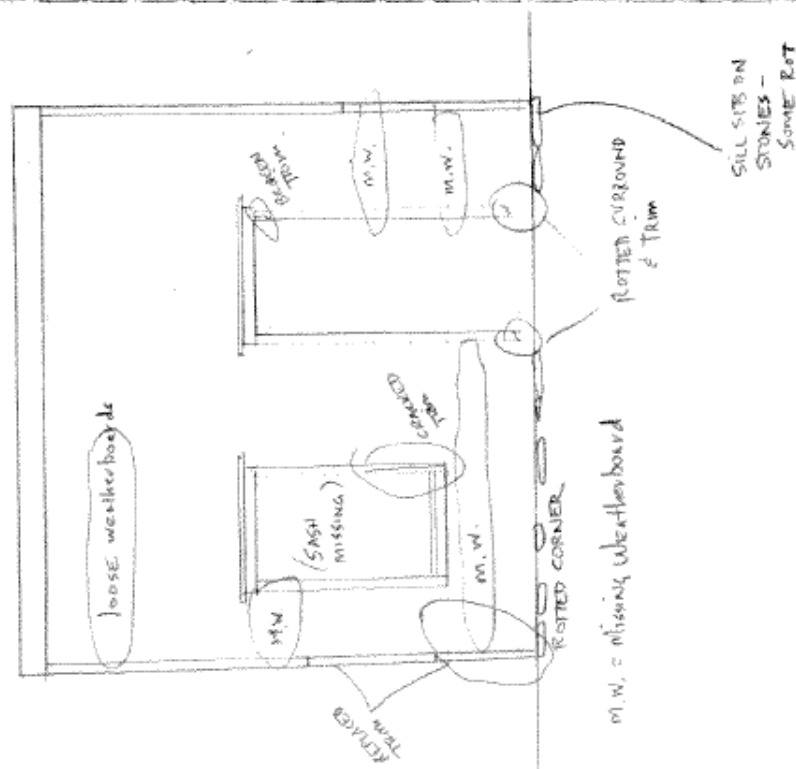
FRONT FACADE - (NOT TO SCALE) (SOUTH)

- 1) WATER DAMAGE TO W. CORNER - ROTTED FRAME & EXT. WEATHER BOARDS.
- 2) MISSING CLAPBOARDS
- 3) ROT TO SILL
- 4) BEAD TRIM AT CORNERS DAMAGED OR REPLACED W/ UNBEADED BOARDS (WIRE NAILS)
- 5) DAMAGE TO WINDOW & DOOR TRIM (MINOR, EXCEPT BASE OF DOOR CURROUND & TRIM)
- 6) DOOR MISSING & WINDOW SASH MISSING

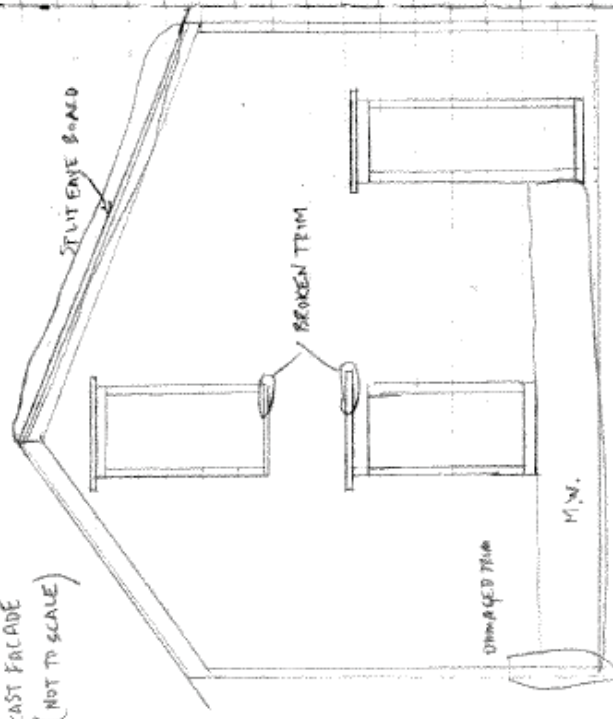
EAST FACADE
(NOT TO SCALE)

- 1) DAMAGE TO TRIM UNDER EAVES (MINOR)
- 2) MISSING WEATHER BOARDS (LOWER LEFT SECTION)
- 3) DAMAGE TO WINDOW TRIM (MINOR)
- 4) WINDOW SASH & DOOR MISSING
